Mechanical Engineering Technical Memorandum 409

**RESULTS OF T56 ENGINE PERFORMANCE MONITORING TRIAL  
IN HERCULES AIRCRAFT, FEBRUARY-JULY 1977**

D.E. GLENNY

APRIL 1981

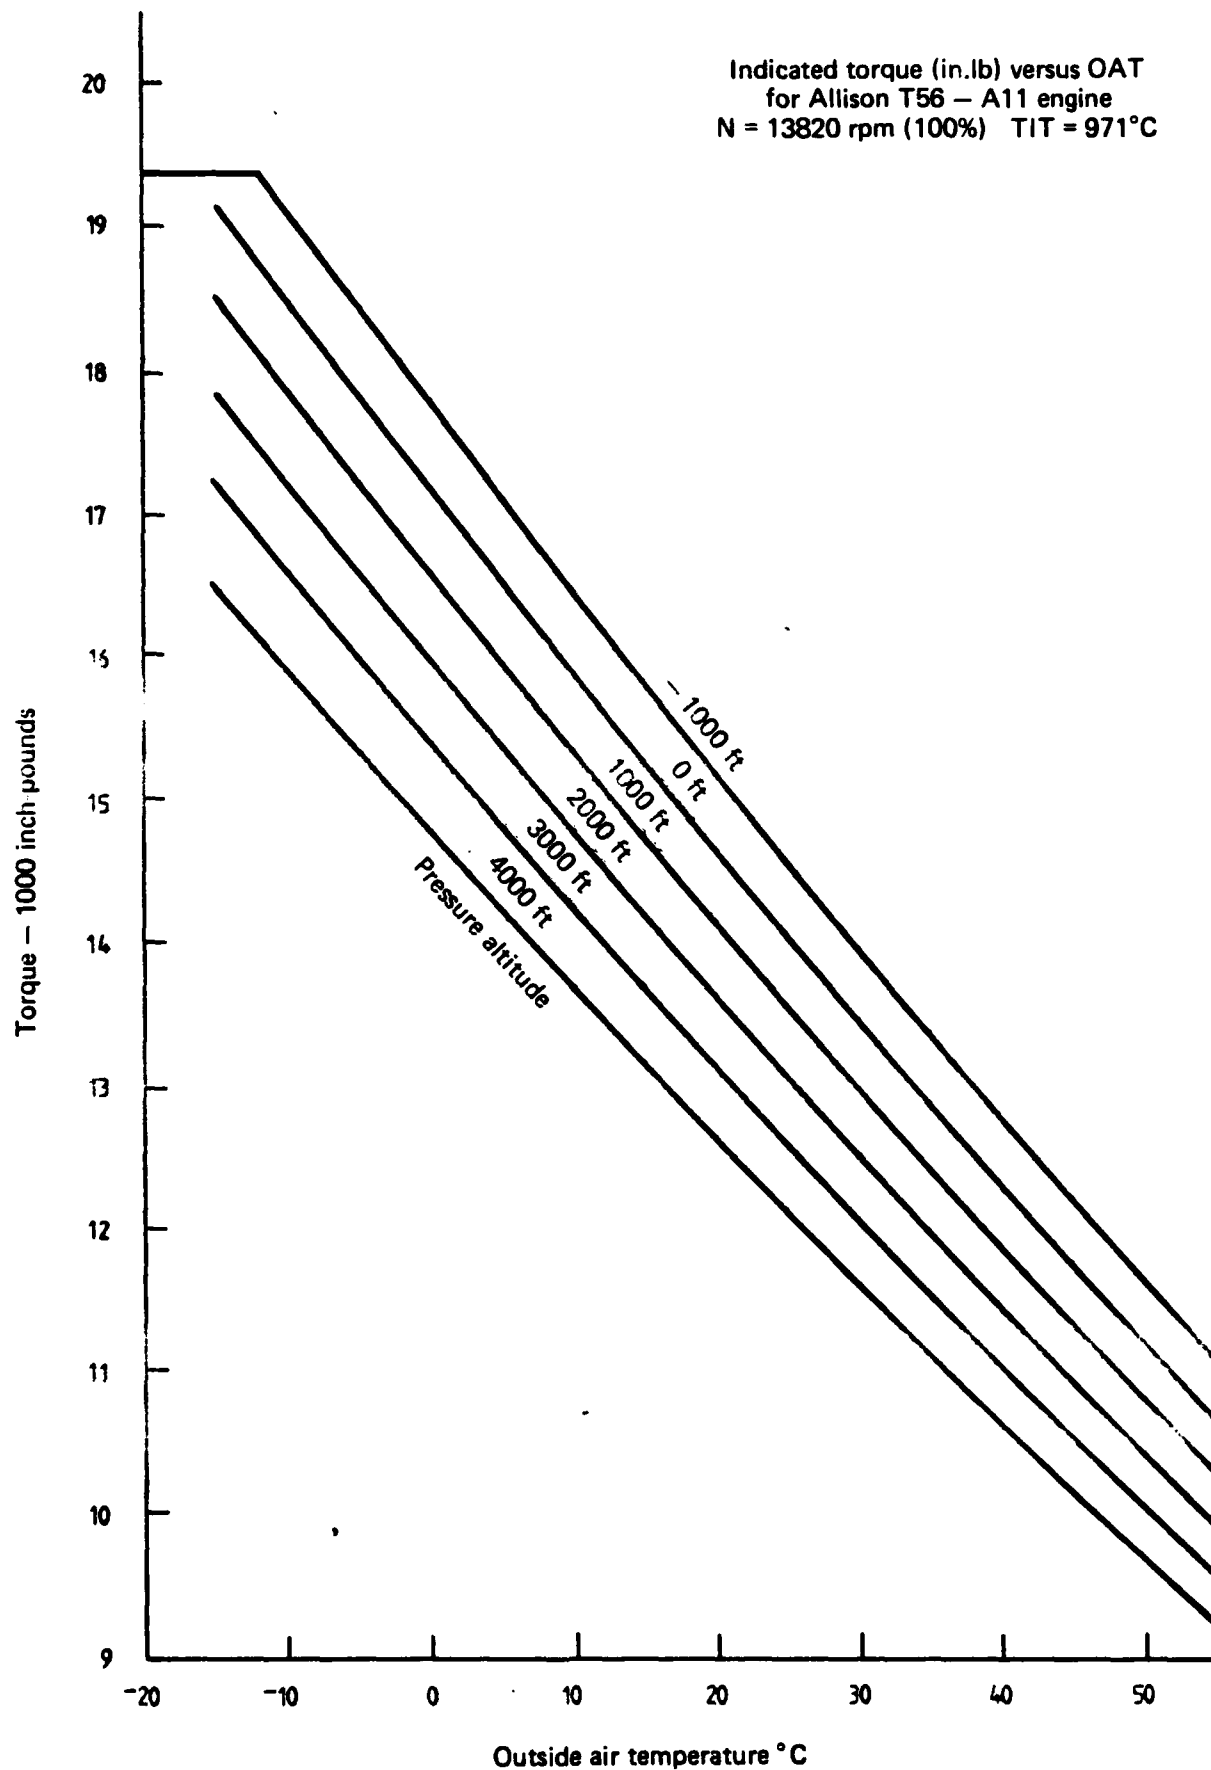
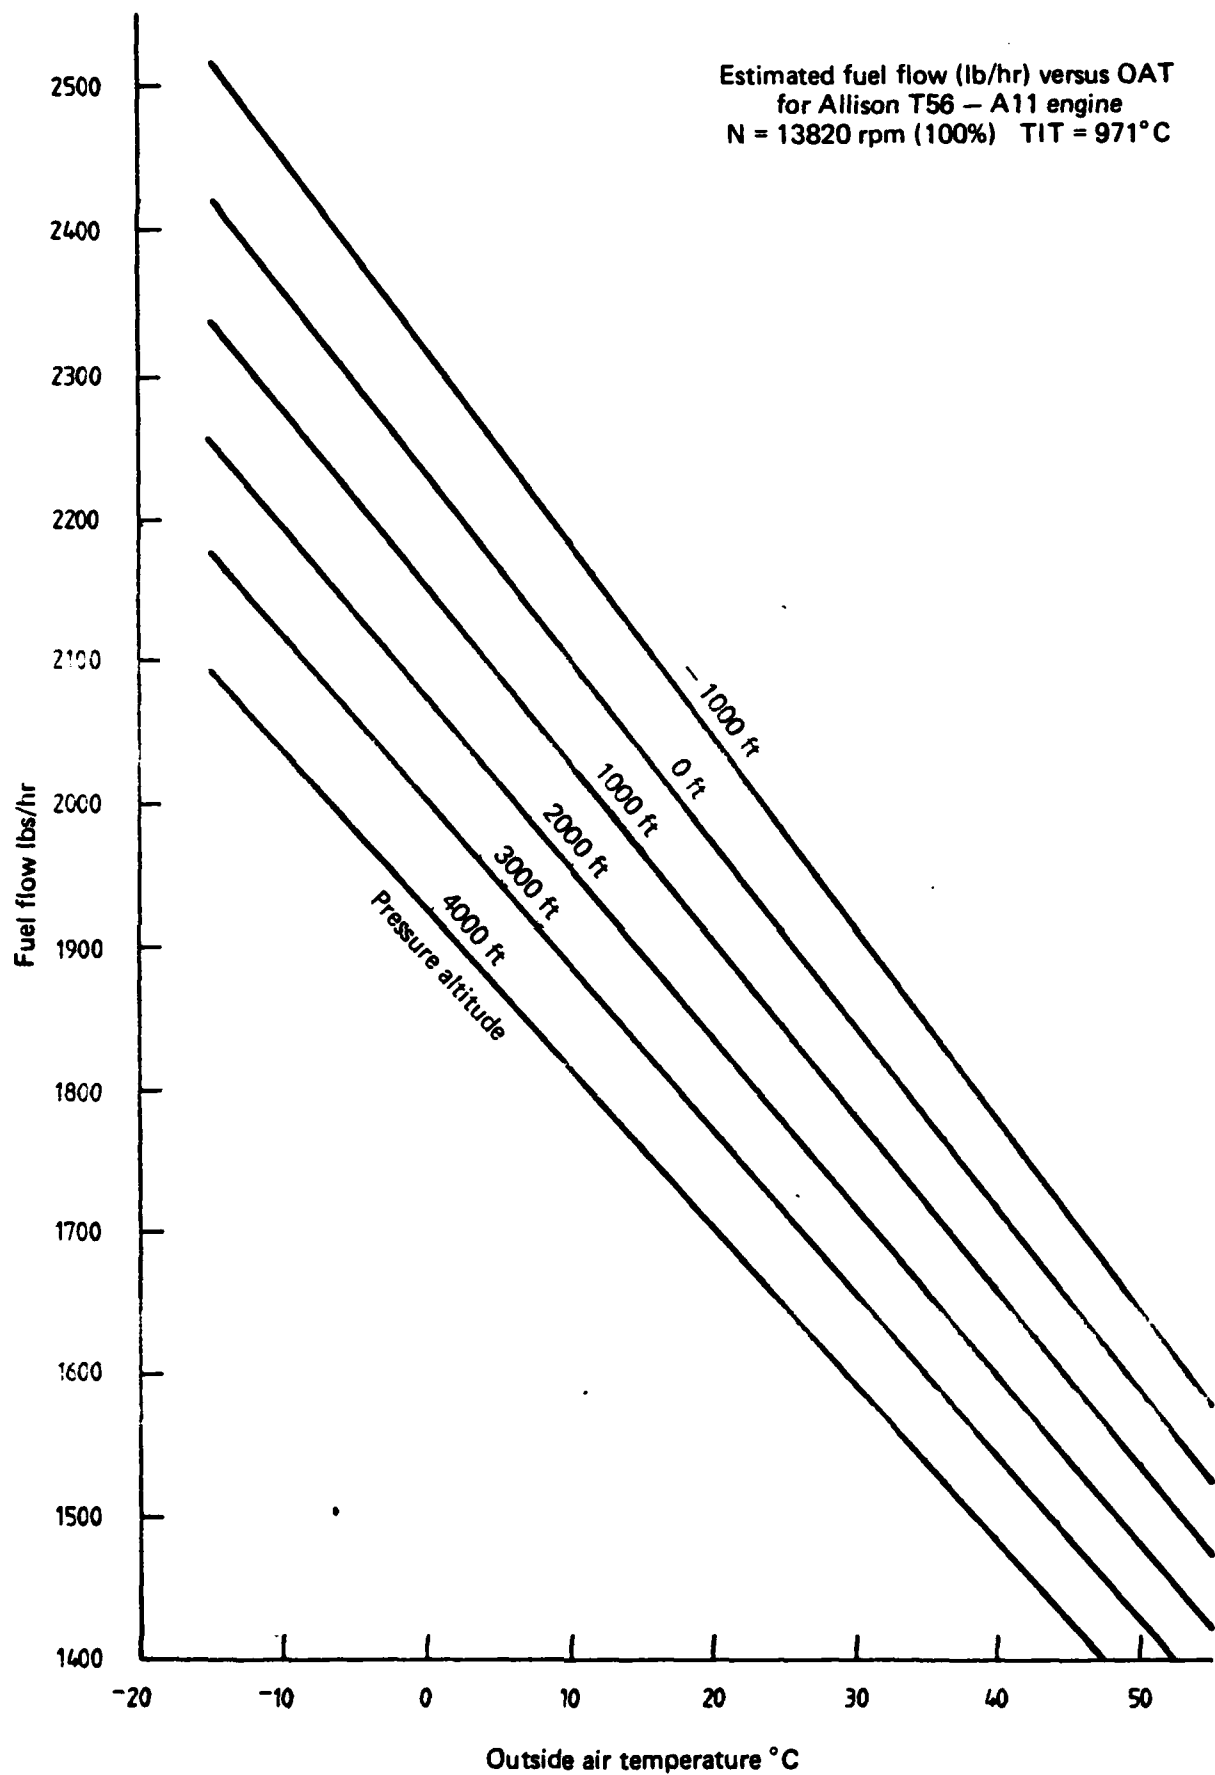
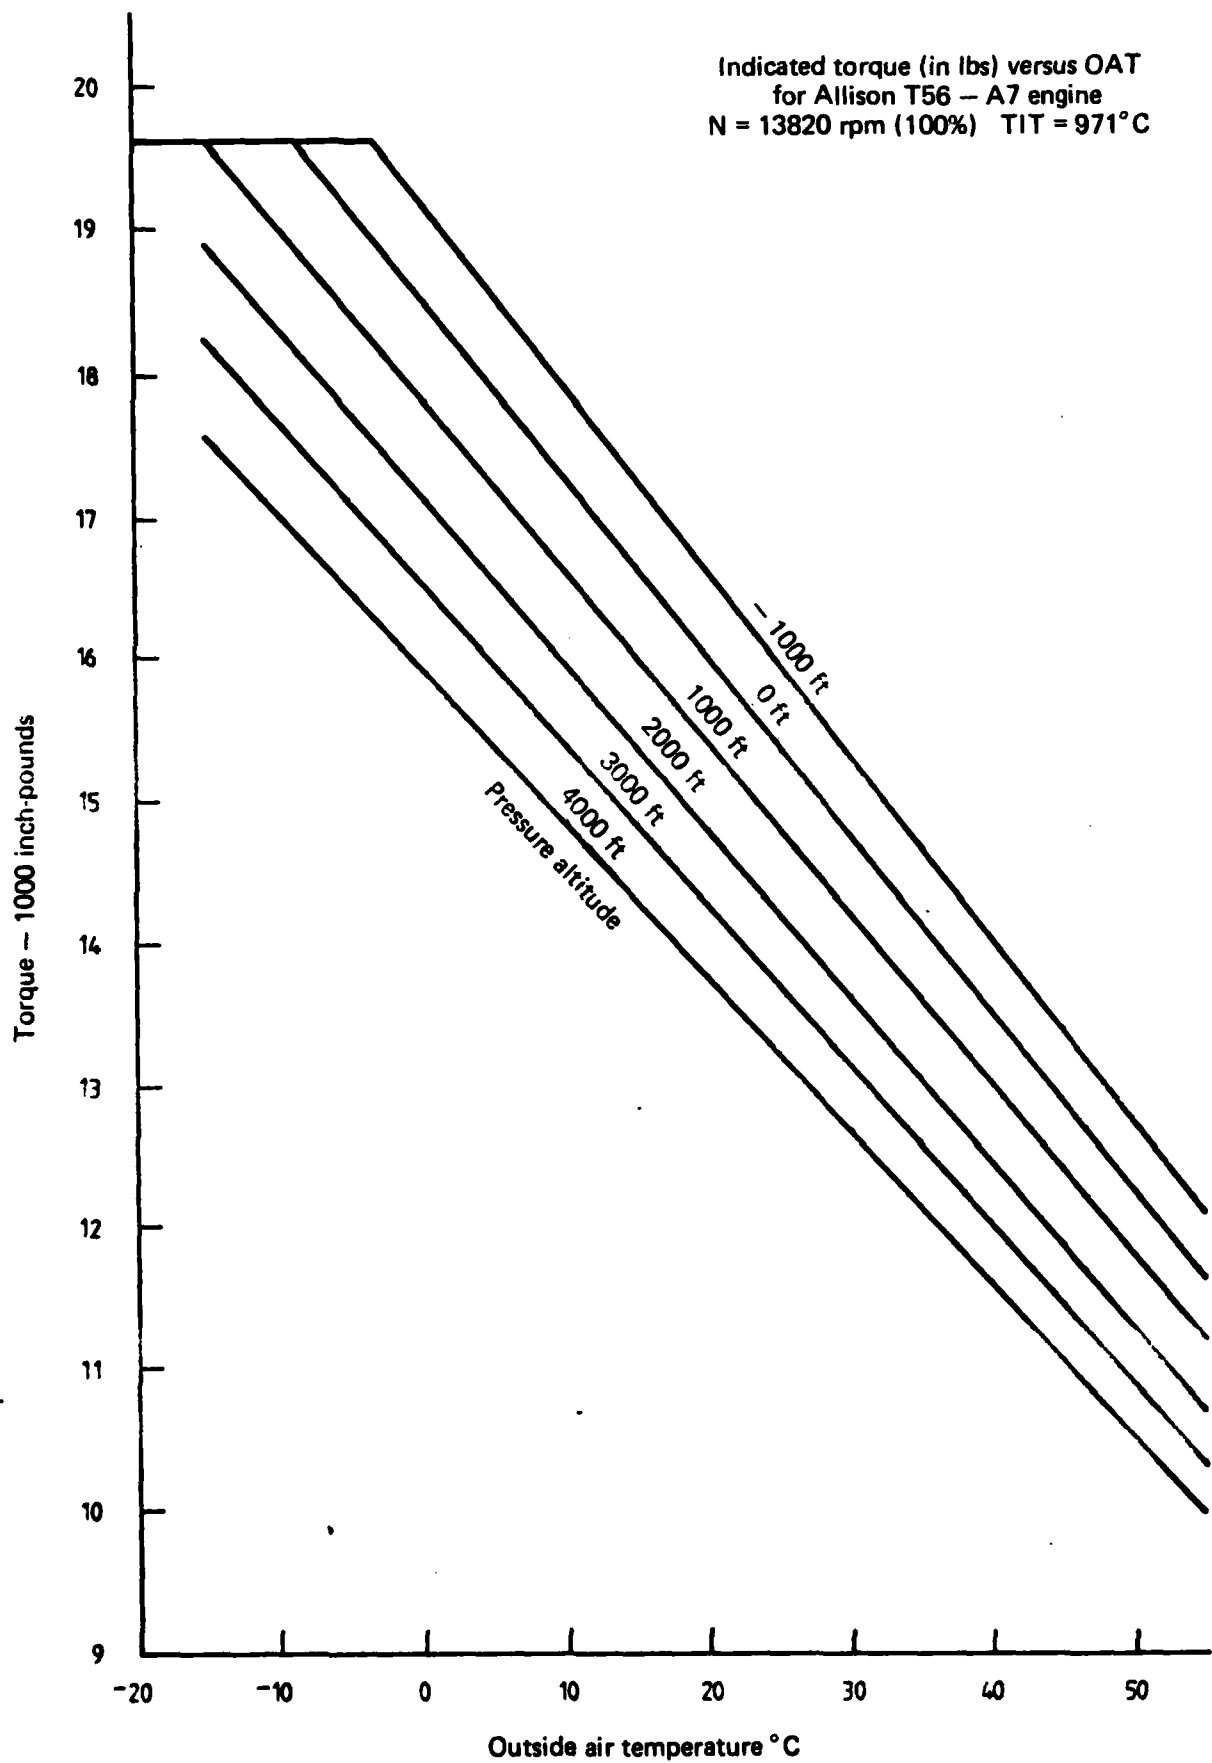
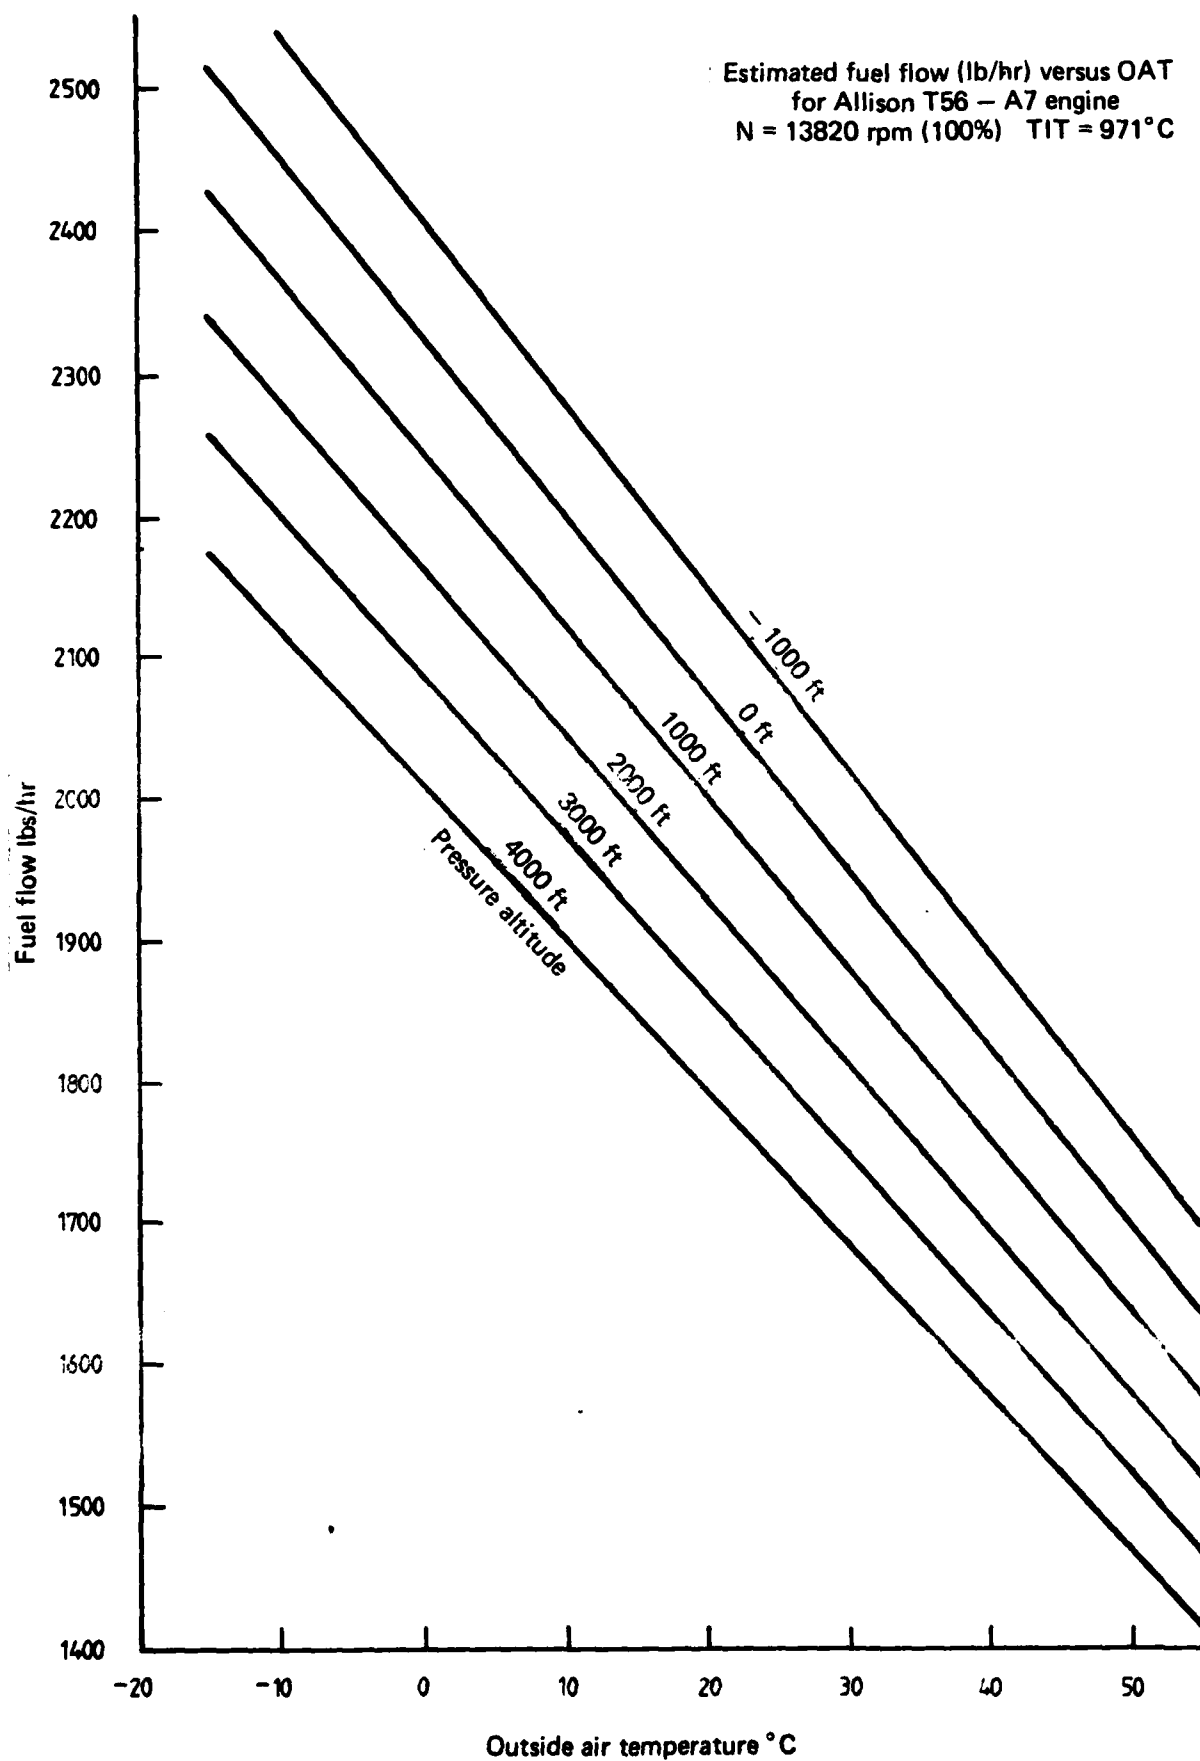
FIGURE 3

6. As mentioned in Section 5 once a change or adjustment has been made to the reference engine (No. 4) the trend plots have to be 'corrected' to account for changes in performance (torque and fuel flow) for that engine. An indication of the new mean levels can be obtained using installation ground power check data along the lines indicated in Figure 3. It should be noted however that as the installation ground power check is carried out at maximum power (as against the part load power checks carried out prior to and in flight) the increments in levels calculated in Figure 3 can only be used as a guide to the direction and maximum amount of movement of the new mean trend lines. In practice new mean levels will have to be re-established using up to 10 plotted points, subsequent to engine adjustment, in the manner described in Section 5d. for each of the 3 engines. If at any time engines 1, 2 or 3 are changed then new mean values of torque and fuel flow should be calculated for that engine irrespective of any results of a ground performance check.

**TYPICAL VARIATIONS TO MEAN TORQUE AND FUEL FLOW LINES DUE TO CHANGE IN SETTING OF REFERENCE ENGINE**

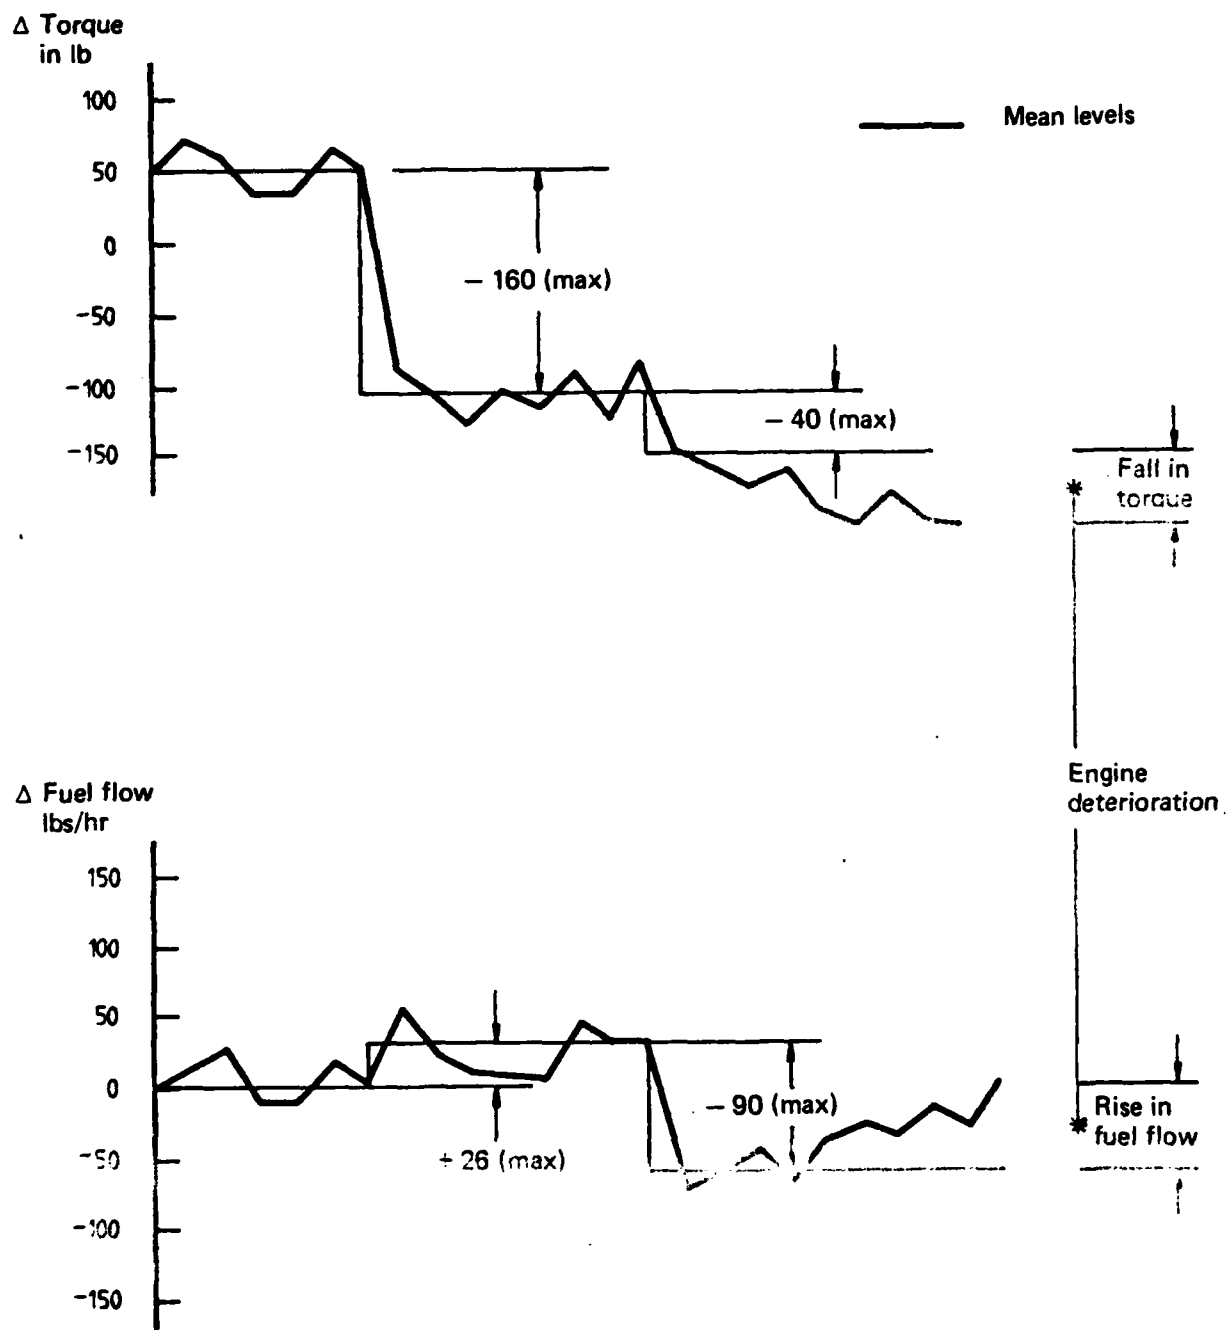
In this case the effect of a. and b., as seen in the sketch below, is to lower the mean lines for both torque and fuel by a maximum of -40 in. lb. of torque and -90 lb/hr of fuel flow respectively. These changes are applicable to engines number 1-3. It should be noted however that the changes indicated, for both mean torque and fuel flow levels, are only given to represent trends and should not be taken as denoting the absolute position of the mean lines after an adjustment or change has been made to the number 4 engine.
